1. Agency Use Only (Leave blank).	2. Report Date. 1990		
4. Title and Subtitle.  Mineralogical Fingerprints for Corrosion Processes Induced		5. Funding Numbers.  Program Element No 61153

# The First Annual Navy Corrosion Control Workshop

# MINERALOGICAL FINGERPRINTS FOR CORROSION PROCESSES INDUCED BY SULFATE REDUCING BACTERIA

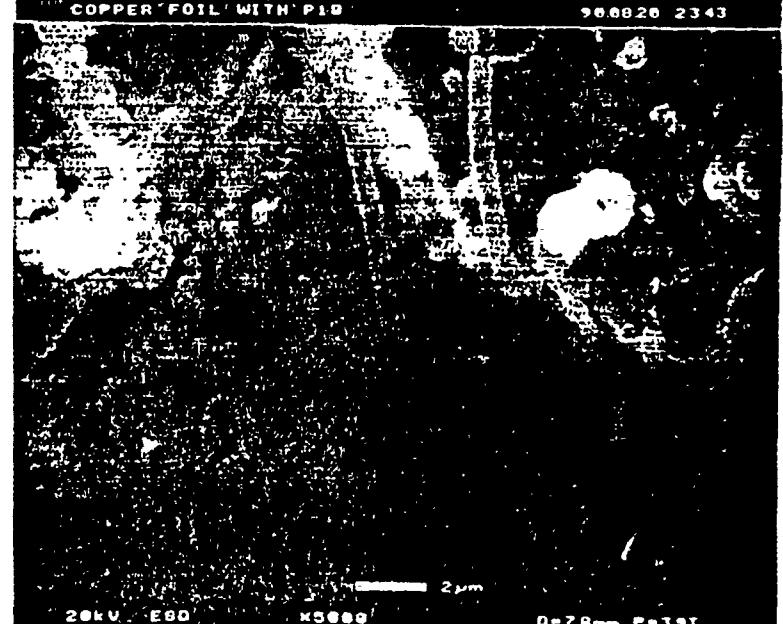
a

Figure 5. Surface of 99Cu after four months exposure to culture VI. Corrosion products have sloughed from surface revealing pitting.

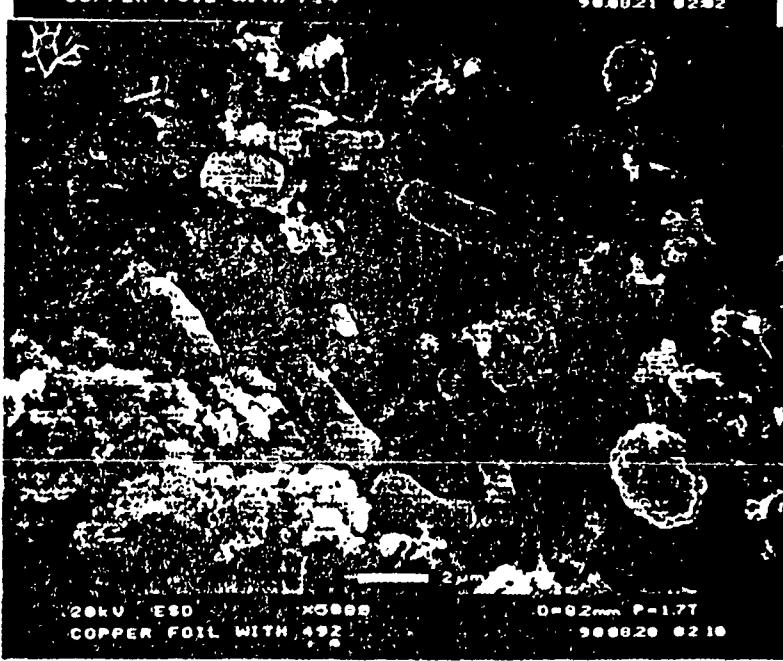
Figure 6. Bacteria associated with corrosion products.

- a. Culture I
- b. Culture II
- c. Culture III
- d. Culture V

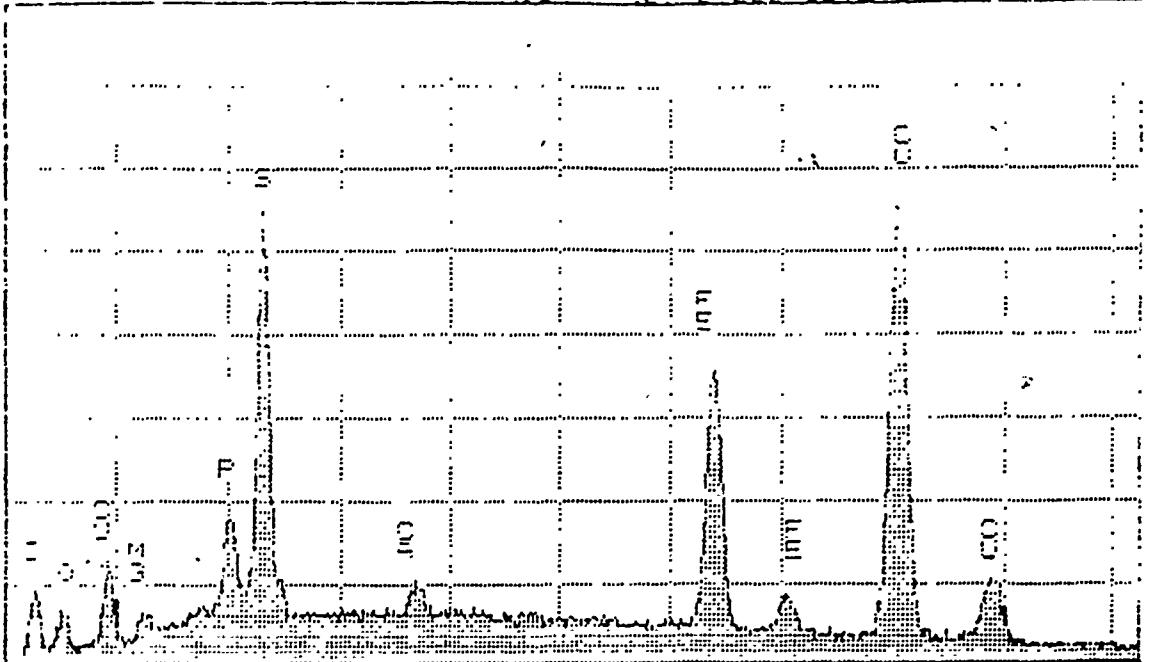
Figure 7. EDAX Spectrum of 99Cu Colonized by Culture IV.

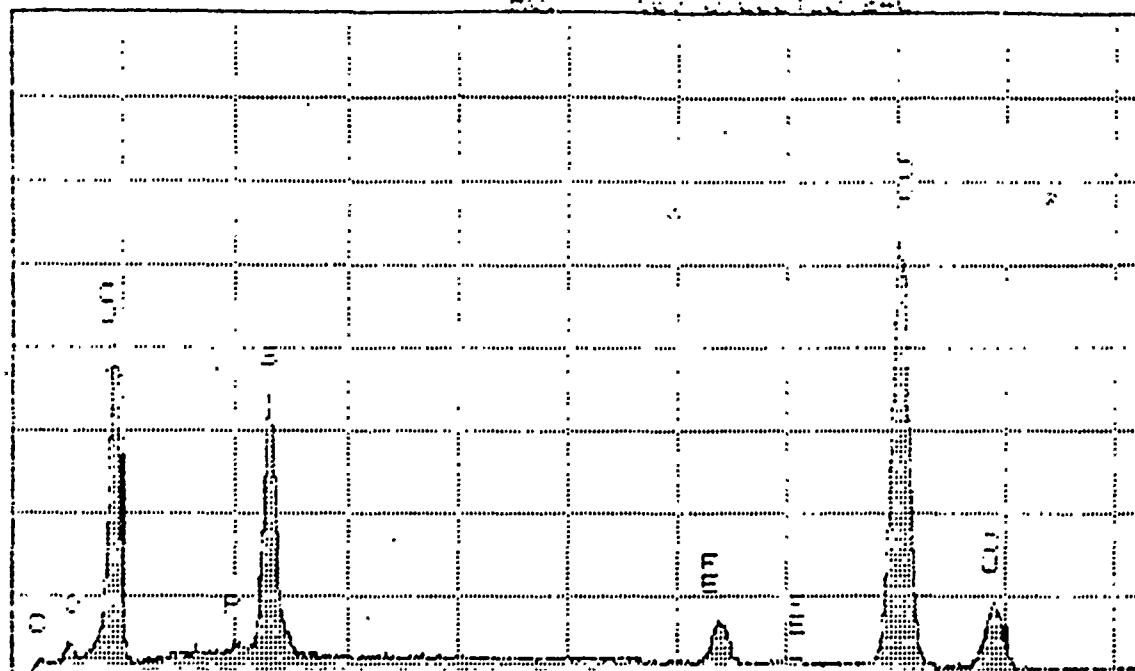
Figure 8. EDAX Spectrum of the 99Cu Metal Surface under Culture IV.
